**Washington Department of Ecology  
Hazardous Waste & Toxics Reduction Program  
Compliance Report**

**Site: King County Airport/Boeing Field**

**RCRA ID#: WAD980986848**

Inspection Date: February 16, 2005

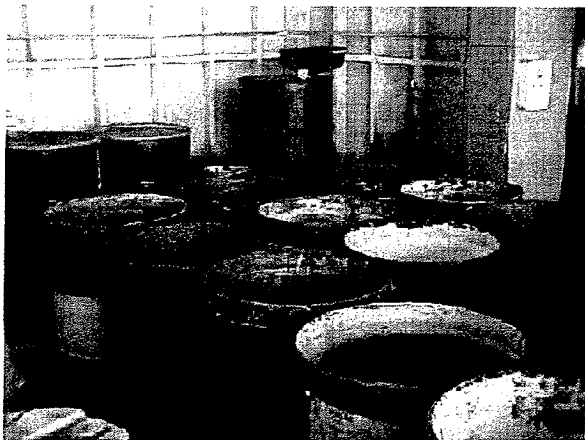
Also in the bull pen area, a 55-gallon drum was being used to collect used oil. The drum sat on a secondary containment pallet. The drum was labeled "Waste Oil" but the label was turned toward the back wall (see photo below - used oil drum is the black drum at the rear with the funnel in the top). Mr. Salazar said he would find out if it was necessary to have this collection drum at all. We asked Mr. Salazar to label the drum as "Used Oil" if its use was continued. We also noted that some secondary containment had been added around the paint thinner drum by surrounding it with 4" x 4" timbers and lining the area with plastic. We mentioned that the fire department would probably like to see a risk label on the drum and that the thinner was considered a product and not a waste as long as it is in use.

The used oil container in the bull pen was labeled as Waste Oil and the label or marking was turned toward the wall so that it was not visible.

*Within 10 calendar days of the receipt of this report, label or clearly mark the used oil container with the words "Used Oil". Send a photograph showing this change to Ecology with your Compliance Certificate (see below) on or before April 29, 2005.*
